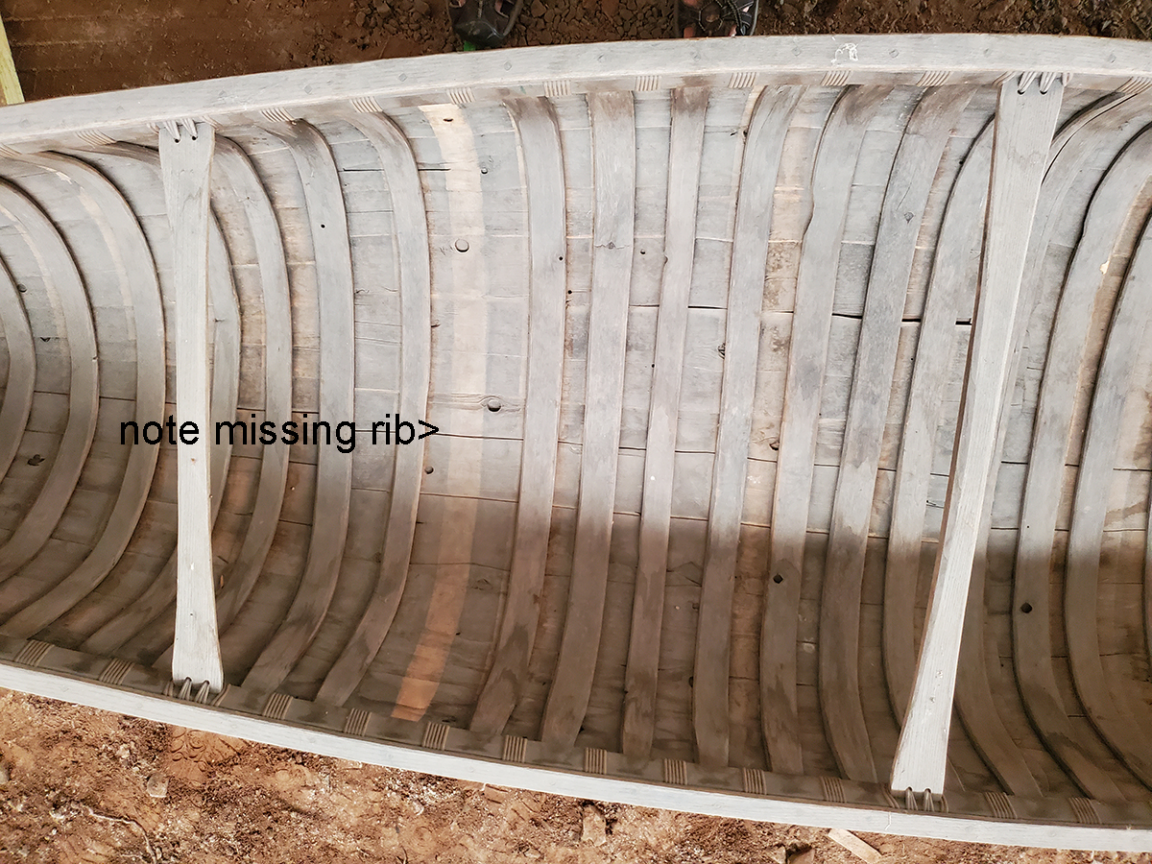
note missing rib>
